From: Howard, Leslie Ann CIV USN BRAC PMO SAN CA (USA)
[leslie.howard@navy.mil]
Sent: Monday, June 22, 2020 5:07 PM
To: Stoick, Paul T CIV USN (USA) [paul.stoick@navy.mil]
Subject: RE: E-2 RACR RTCs
Attachments: RTC – D_RACR_Parcel E-2_r1F.pdf

When you have a chance, can you forward the Parcel E-2 RACR RTCs. Thomas said the waterboard was asking if their comments were being addressed and didn't want it finalized until they were. I didn't think the water board had major comments – but I'll take a quick look.

At the request of APTIM, NOREAS, supported the Shoreline Revetment, Site Grading, Consolidation of Excavated Soil, Sediment & Debris, and Upland Slurry Wall Installation Remedial Action at Parcel E-2 Hunters Point Naval Shipyard San Francisco Project (hereafter referred to as the Project). This memorandum (memo) provides responses to comments that NOREAS received from APTIM on 31 March 2020, on the aforementioned Project's Biological Resource Activity Completion Memorandum; which NOREAS transmitted to APTIM on 9 January 2019.

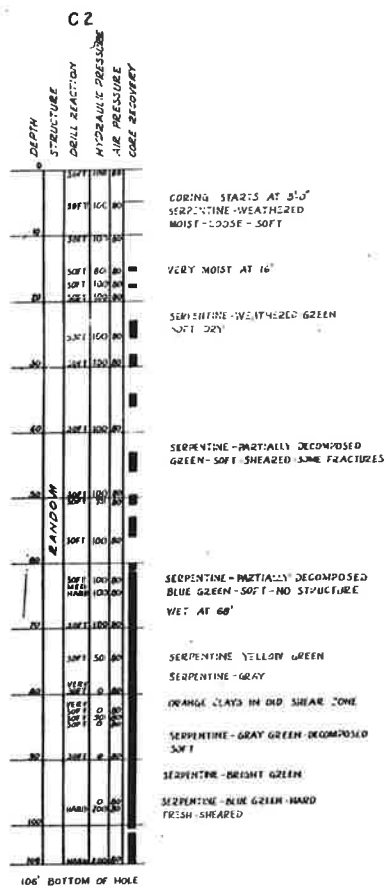
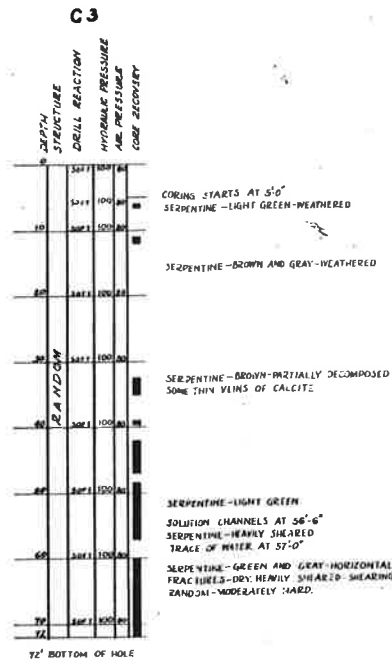
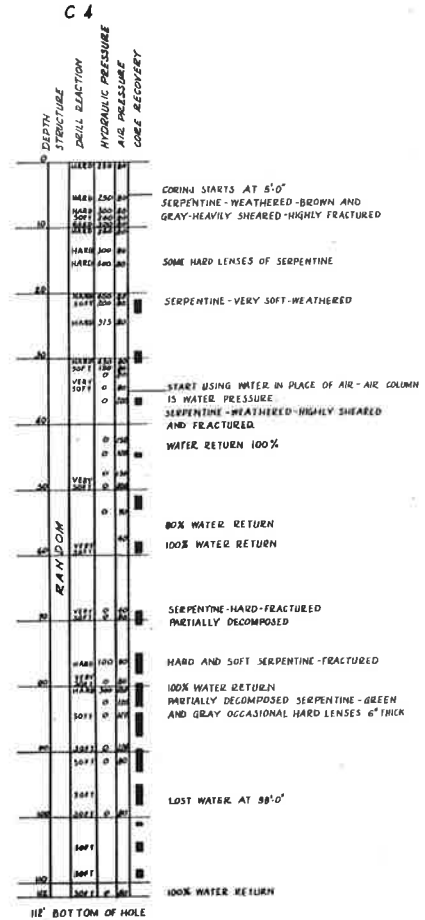
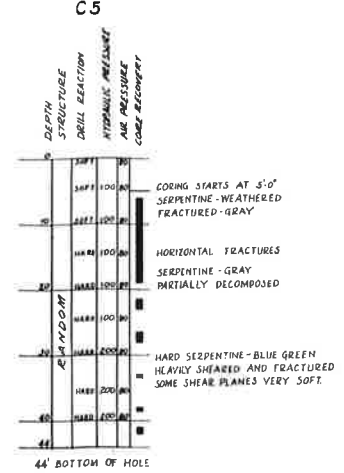
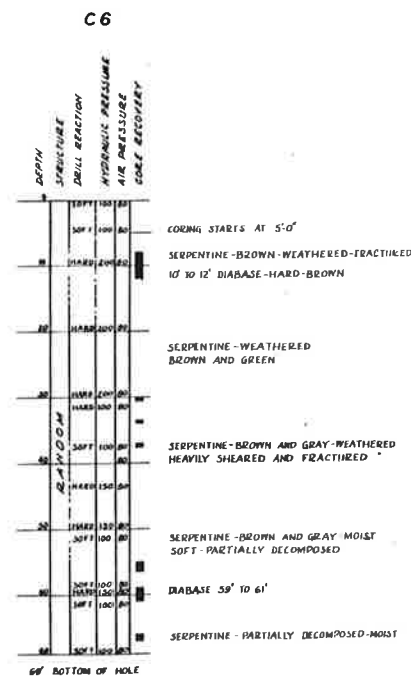
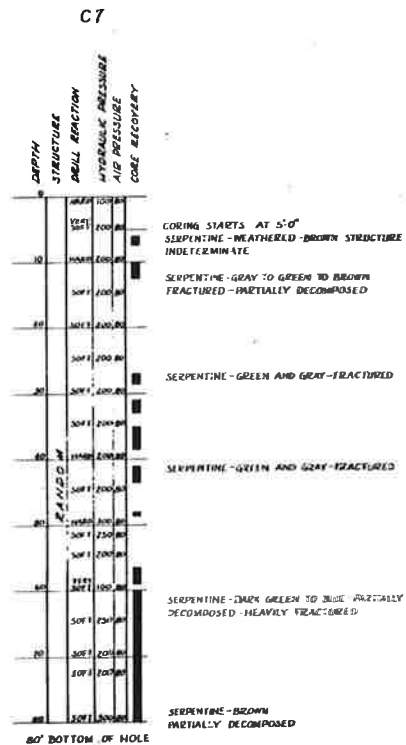
NOTE:
ALL CORE FROM THESE HOLES WERE 3 1/2" IN DIAMETER CUT BY A 6" SAWTOOTH TYPE BIT ON A CORE BARREL. CAPABLE OF RECEIVING 5'0" OF CONTINUOUS CORE. ALL HOLES WERE DRILLED WITH AIR EXCEPT WHEN AIR FAILED TO REMOVE SUFFICIENT CUTTINGS OR WHEN EXCESSIVE SAVING IN THE HOLE OCCURRED. WHEN WATER WAS USED SUFFICIENT BENZONITE WAS USED TO RETAIN THE HOLE AND TO REMOVE CUTTINGS, AS IN HOLE C4. IT WAS FOUND THAT IN THE SERPENTINE CORING WITH AIR WAS THE BEST MEANS OF OBTAINING RECOVERY.

EXPLANATION OF COLUMNS
STRUCTURE—GEOLOGIC
DRILL REACTION—THE WAY MATERIAL DRILLED, VERY SLOWLY OR SLOW FOR HARD ROCK, VERY FAST OR FAST FOR SOFT ROCK.
HYDRAULIC PRESSURE—THE HYDRAULIC PRESSURE AS APPLIED ON THE BIT AS IT DRILLED.
AIR PRESSURE—THE AMOUNT OF AIR REQUIRED TO BLOW DRILL CUTTINGS FROM HOLE.
CORE RECOVERY—PRESENTED IN GRAPHIC FORM AS SOLID COLUMNS.
